2008/2009 Annual Inspection Report

FOUR MILE CANAL TERRACING AND SEDITMENT TRAPPING PROJECT (TV-18)

State Project Number TV-18 Priority Project List 9

October 9, 2008 Vermilion Parish

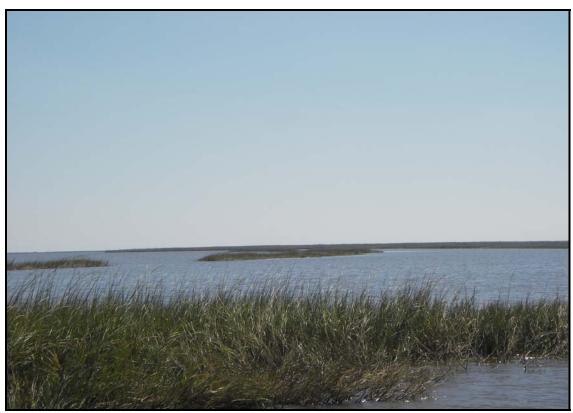
Photo No. 1, Little White Lake terraces

Little White Lake Terraces, for the most part, survived the storm intact. Vegetation is recovering. The 4th row of terraces has only three terraces remaining. The third row is in relatively good condition. The first and second rows are in excellent shape. Sediment has been deposited in the channel right at the entrance to the terrace field. Whether this is a result of the hurricane is unknown. Four Mile Canal northern most terraces continue to erode as well as the western most terraces. Vegetation is recovering. Channels between the terraces also are silting in. No maintenance needed at this time. (Photos: Appendix B, Photo 1-2)

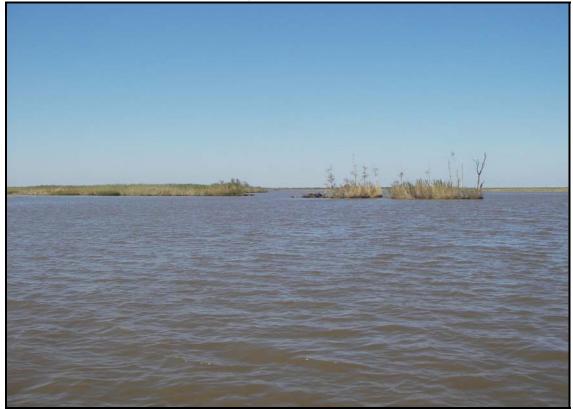
Photo No. 2, Four Mile Canal terraces

Item	Condition	Pysical Damage	Corrosion	Photo #	Observations and Remarks
Steel Bulkhead	N/A				
/ Caps					
Steel Grating	N/A				
Stop Logs	N/A				
. •					
Hardware	N/A				
Timber Piles	N/A				
Timber Wales	N/A				
Galv. Pile Caps	N/A				
Gaiv. Pile Caps	IVA				
Vegetation	Good				
Signage	N/A				
/Supports	IVA				
Rip Rap (fill)	N/A				
Eathern					
Embankment				1 & 2	
Terraces	Good				Expected erosion on sacrificial terraces. Significant erosion on terraces adjacent to Vermilion River Cut Off.
